**FEDERAL AVIATION ADMINISTRATION
AIRWORTHINESS DIRECTIVES
LARGE AIRCRAFT**

BIWEEKLY 2000-01

LARGE AIRCRAFT

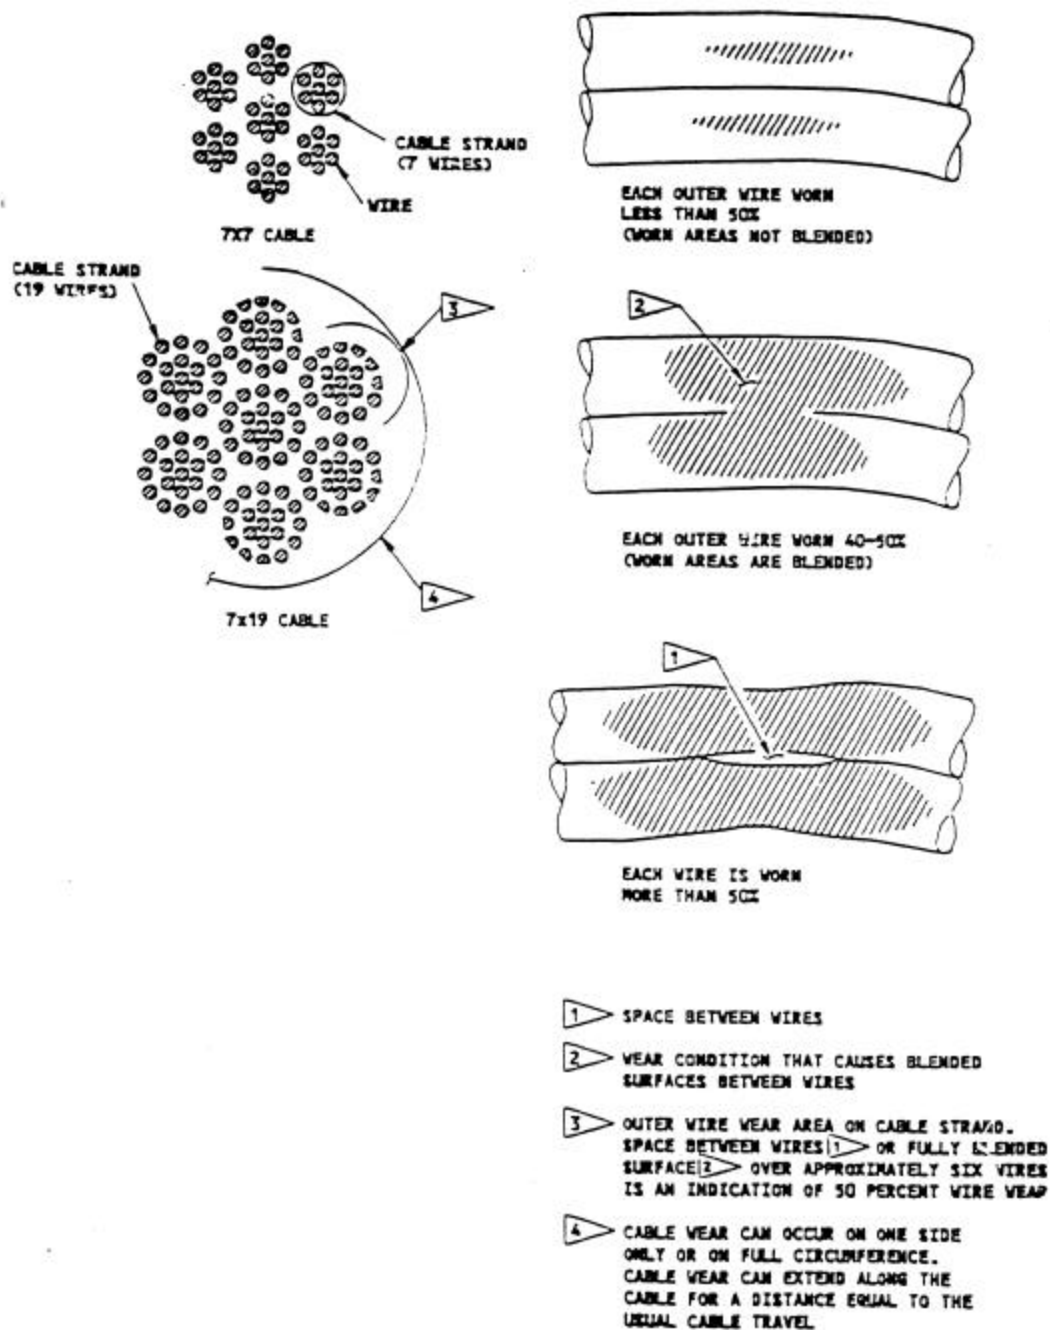
FIGURE 1

(1) One cable strand had worn wires where one wire cross section is decreased by more than 40 percent (see Figure 1),

B. Perform a detailed visual inspection of the cable runs to detect incorrect routing, kinks in the wire rope, or other damage. Replace the cable assembly if:
